8. Description of Work Accomplished

N3866M

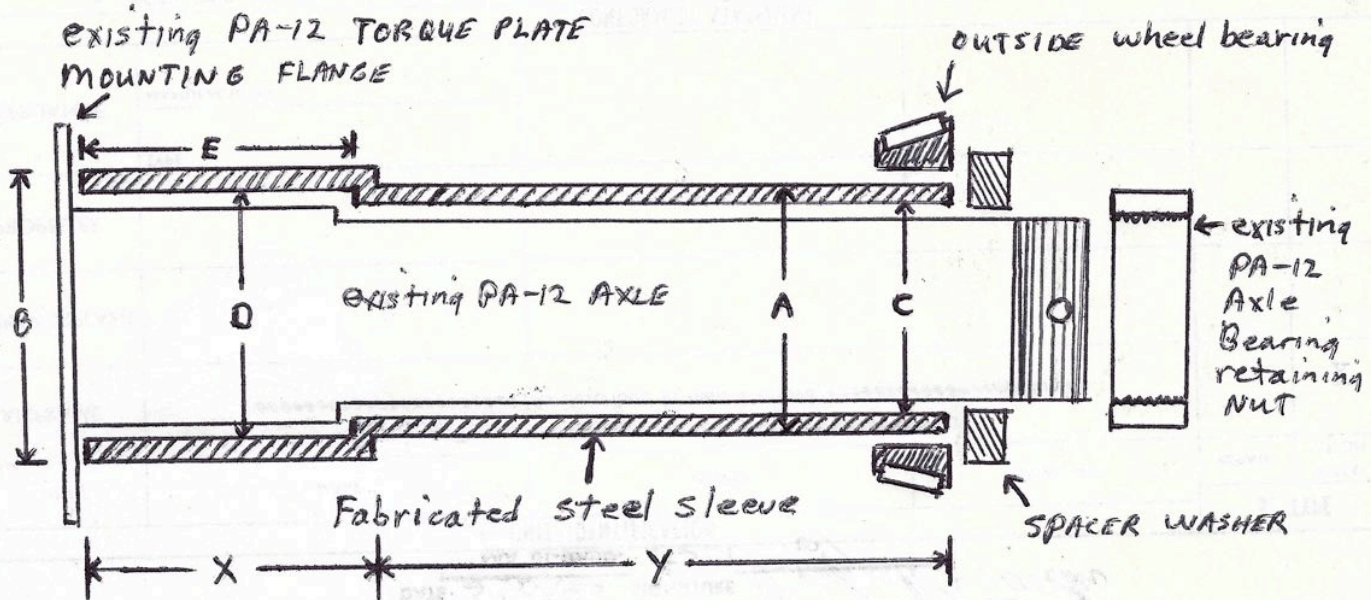
Dimensions ABXY conform exactly to Piper Part # 63303-02 (03) stub axle.

Dimensions CD allows for shrink fit over PA-12 axle.

Dimension E allows fabricated steel axle sleeve to butt on existing PA-12 torque plate mounting flange.

Spacer washer provides retention for outside wheel bearing and to take up clearance between outside of wheel bearing and existing PA-12 axle bearing retaining nut.

Aircraft modified by removing existing wheels, tires and brake assembly and installing fabricated steel axle sleeves on both existing main gear axles with PA 28-160 wheel assembly Piper Part # 451-769, brake assembly Part # 451-718, torque plate assembly Part # 755-818 and 8.00-6 tires and tubes. The fabricated axle sleeves conform exactly to the dimensions of PA 28-160 stub axle Part # 63303-02(03) to accommodate wheel assembly Part # 451-769.
